# Victoria the 'Stalifornian'

**Tim Sears, Bordon, Hampshire**

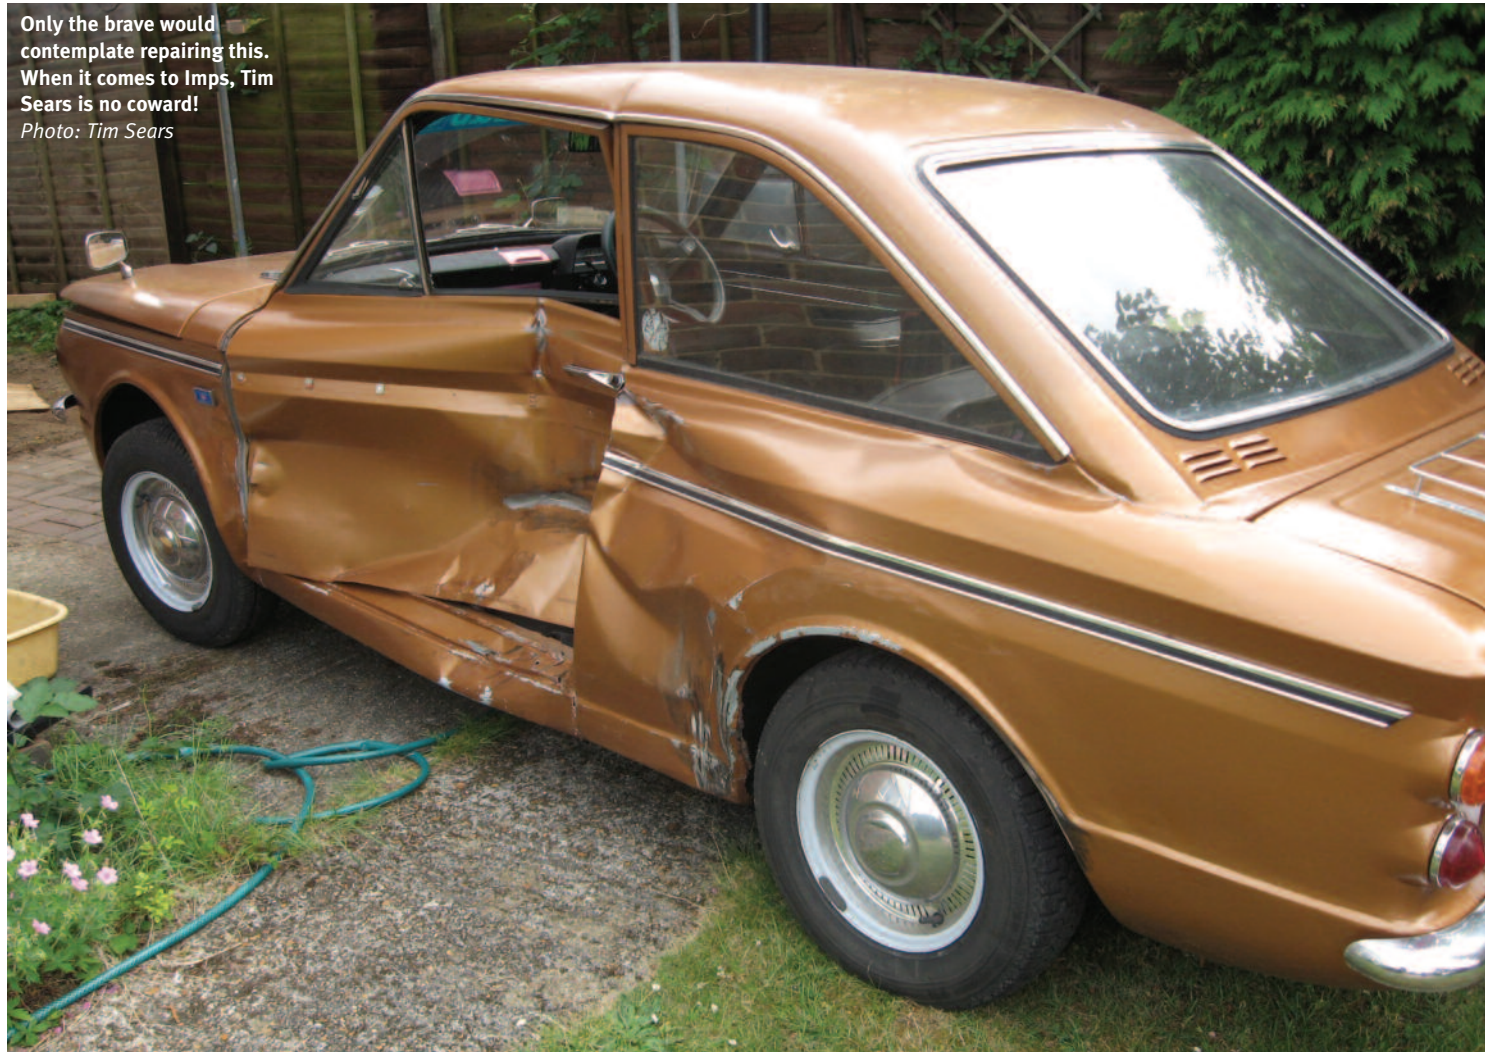
Only the brave would  
contemplate repairing this.  
When it comes to Imps, Tim  
Sears is no coward!  
Photo: Tim Sears

A ten-tonne PortaPower was then bought and the straightening began. I soon realised that pushing against the driver's sill section to straighten the passenger's side could damage the good sill.

The solution was to cut away the passenger side outer sill and then inner sill and leave the C-shaped section which was much easier to manipulate. The same approach was then taken with the rear wing front

section and B-post. The badly damaged part of the wing was cut away leaving the B-post much more accessible to the PortaPower, hammer and dollys. The delicate use of both club and sledge hammers saw the A-post straighten enough to be able to fit the replacement door. The PortaPower was then used to tweak the roof and B-post to fit the door.

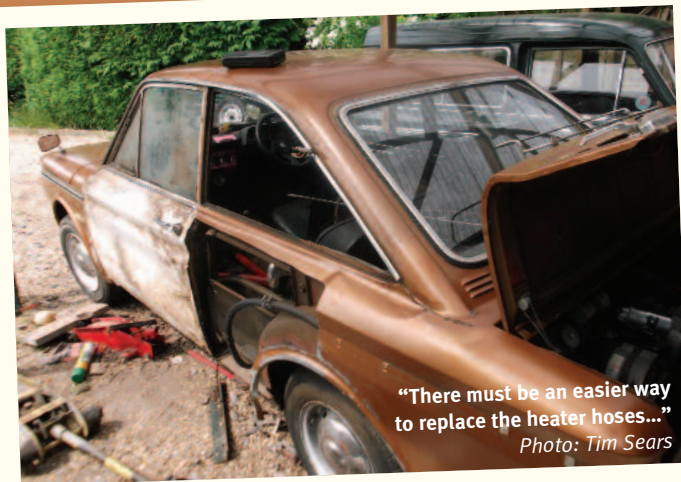
**“There must be an easier way to replace the heater hoses...”**  
Photo: Tim Sears

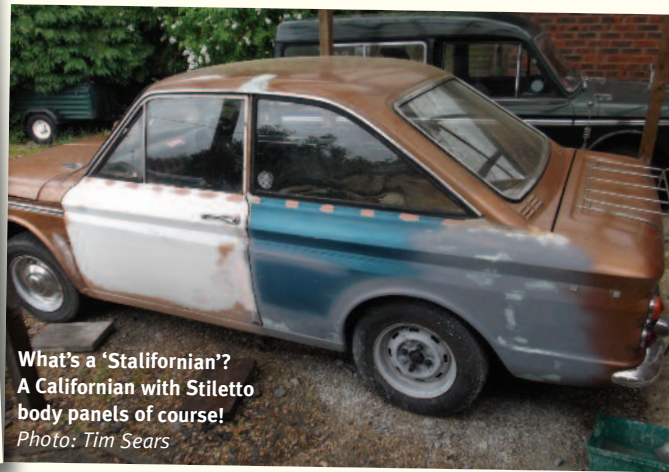
**What’s a ‘Stalifornian’?  
A Californian with Stiletto  
body panels of course!**  
Photo: Tim Sears

By 2013 Dave had now donated a Stiletto shell to *Victoria's* cause, this would be cut up to not only supply the section of rear wing but also the scuttle, parts of the floor and rear suspension

2014 arrived and once the Stiletto rear wing section was welded in a new inner sill was made and fitted and then outer sill and sill extension added. At this point I considered leaving the Stiletto trim on the passenger side of *Victoria* but eventually sanity prevailed and the holes were welded and Californian trim holes drilled in the door and wing. The damaged headlining was removed by Rosie and a roll of trim material bought. A new headlining was made (relatively easy on a coupé) and stuck in place.

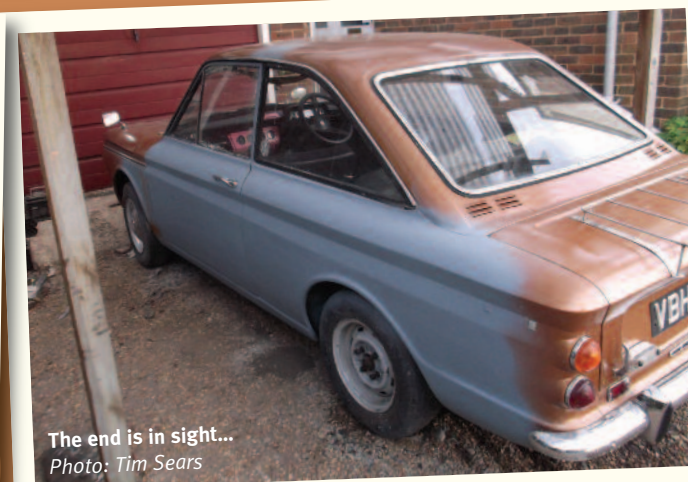
**The end is in sight...**  
Photo: Tim Sears

A couple of weekends and some long summer evenings and the new parts of bodywork were blended in and painted. A mechanical check over and *Victoria* was booked for her MoT test. This was now October 2014. Having not turned a wheel on the road for three and a half years I would be followed to the MoT test station by my wife Vanessa and daughters Demelza and Rosie in Vanessa’s everyday Mk1 Imp carrying tools and spares just in case. These were not needed and *Victoria* behaved *impeccably*, passing her MoT test with no issues or advisories. My MoT tester,

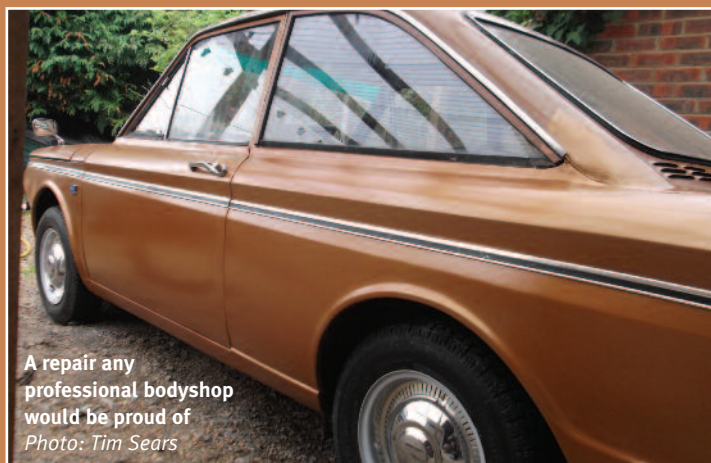
**A repair any professional bodyshop would be proud of**  
Photo: Tim Sears
